Hudson River Estuary Watershed Assessment & Outreach Project

2007 Watershed Report Card for Normanskill Watershed

A Hudson Basin River Watch Watershed Assessment & Outreach Project

Normanskill Watershed

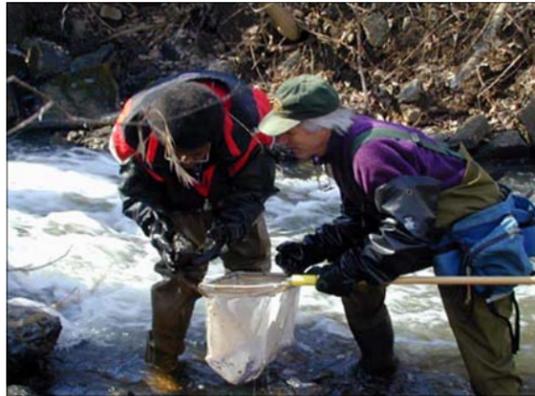
The NYS DEC Stream Biomonitoring Unit's (DEC SBU) methodology was used for all sample collection and analysis tasks. These methods involve collecting, sorting and analyzing a sample of benthic macroinvertebrates (stream bottom-dwelling organisms with no backbone that are visible to the naked eye). These organisms vary in their sensitivity to water quality impacts. DEC SBU's methods use the presence or absence, relative abundance, and diversity of species to obtain an overall water quality score called the Biological Assessment Profile (BAP). BAP is scored 0-10, with 10 indicating the best water quality. The DEC SBU also uses four narrative descriptions of water quality based on the BAP score as illustrated in this graph:

It's important to note that the term "slightly impacted" can be misleading if it's taken out of context. Sites with water quality at only 5.1 on the BAP scale, or almost "moderately impacted", can be described as only "slightly impacted".

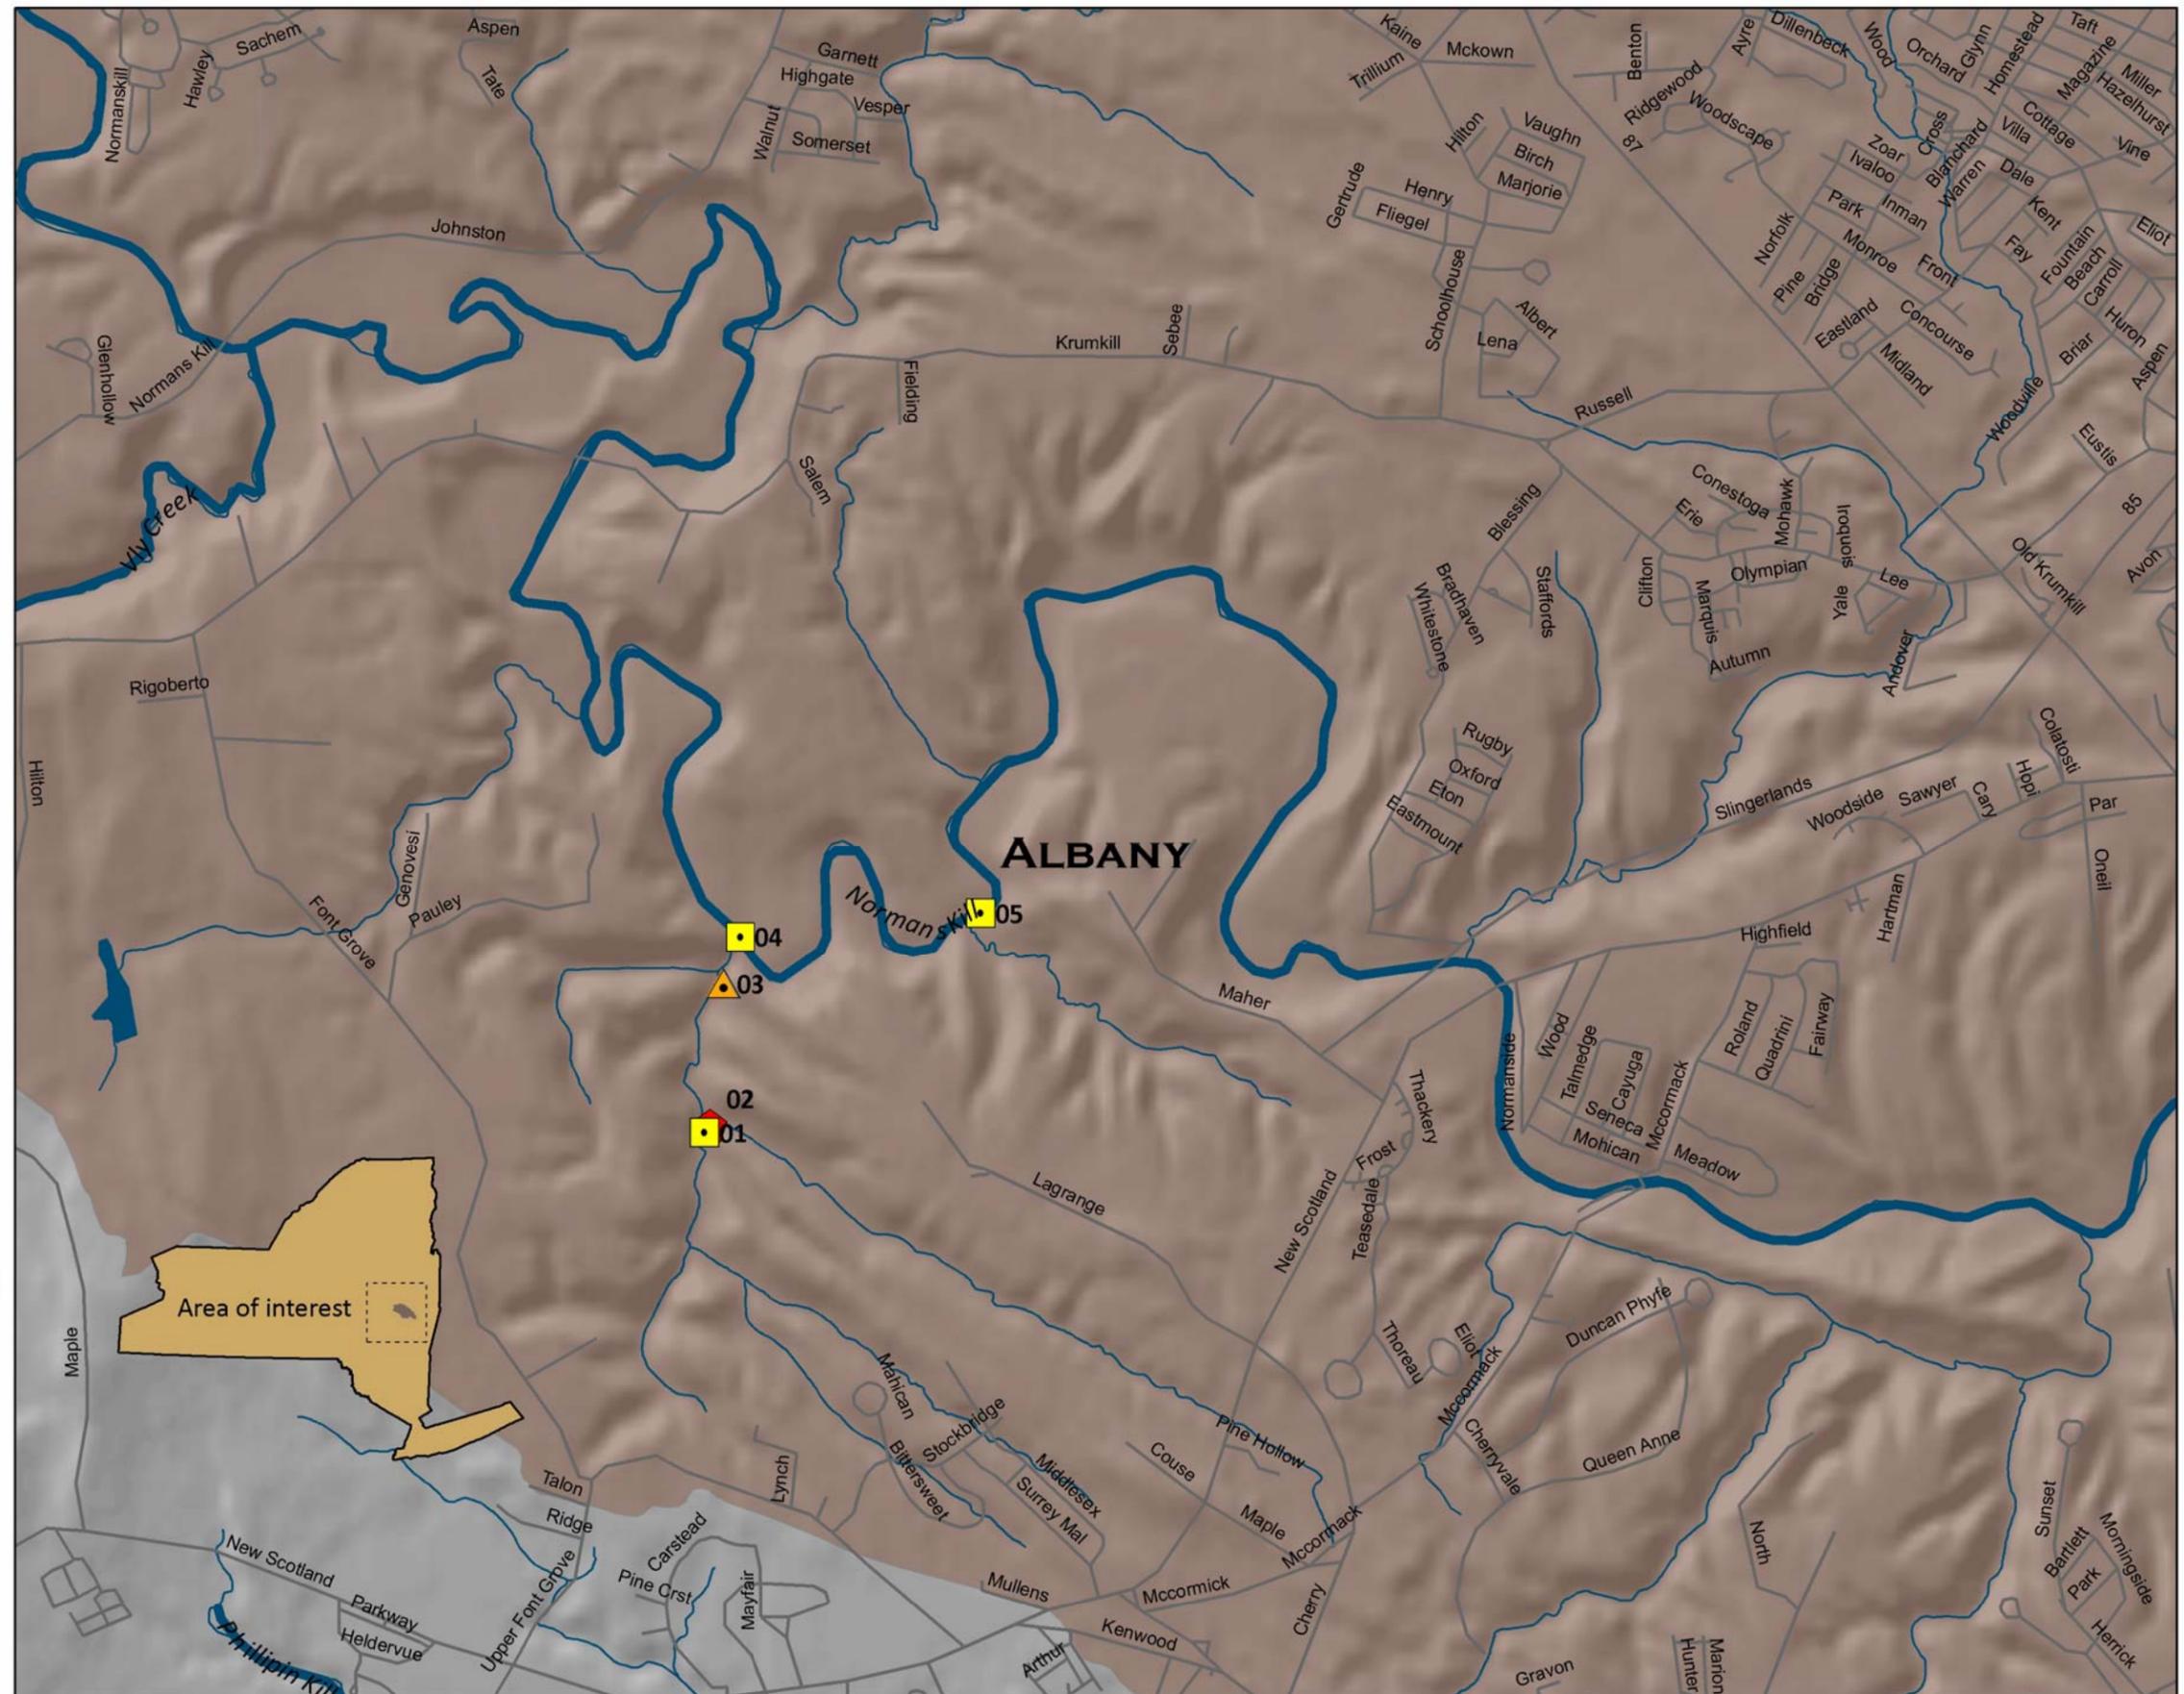
Station NORM 01 (Unnamed Tributary) is located just above the confluence on the southern tributary. The Biological Assessment Profile (BAP) score, 5.6, indicates moderately impacted water quality. The Impact Source Determination (ISD) indicated a community affected by nonpoint sources.

Station NORM 02 (Unnamed Tributary), is upstream from NORM01 on the southern tributary. The BAP score was 1.6 indicating severely impacted conditions. The ISD was inconclusive as results were less than 50% similar to any category.

Station NORM 03 (Unnamed Tributary), is located just above the confluence with the Normanskill. The BAP score was 5.2, indicating moderately impacted conditions. The ISD was inconclusive as results were less than 50% similar to any category.

Station NORM 04 (Normanskill), is located above the confluence with the southern tributary. The BAP score was 5.6 indicating moderately impacted conditions. The ISD indicated a community affected by municipal, industrial, and toxic additions .

Station NORM 05 (Normanskill), is just below confluence with the northern unnamed tributary. The BAP score was 6.5 falling within the slightly impacted category. The ISD indicated a community affected by toxic, organic and siltation additions.

Many factors influence the BAP score. Professional guidance should be sought from HBRW, the NYS DEC SBU, or other qualified sources about data interpretation questions. In general, however, sites with BAP scores below 7.5 usually warrant further investigation. Sites below 5.0 should be subject to detailed study to identify the source(s) of impairment and guide water quality improvement measures.
